G503 WWII Military Jeep Radiator Rebuild Restore WW2 Restoration

This article shows a step by step process of restoring your G503 WWII Jeep Radiator - By Lew Ladwig

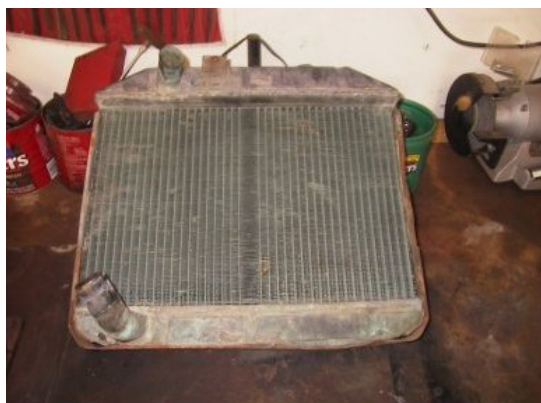
I found a good GPW radiator. Most of the thin fins are bent over but the tubes look to be OK. It has the correct 45 cut on the sides and the center missing tube. The tanks have several dents and the bottom tank is bulged out. This is probably due to freezing. My plan is: 1) Measure frame 2) remove frame 3) remove tanks 4) clean and rod 5) pound out tank dents etc. 6) straighten fins - remove tarnish 7) resolder 8) add shroud 9) add over flow tube 10) paint 11) zinc plate carriage bolts

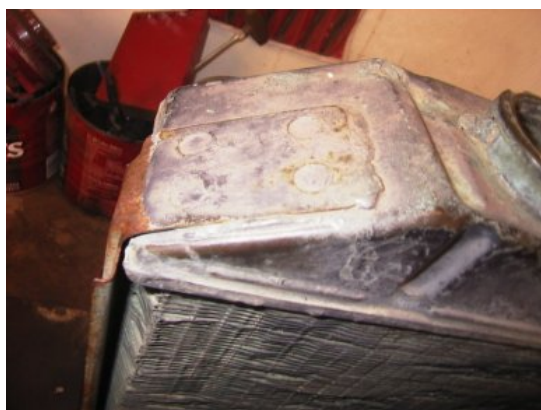
You can see where the frame is soldered to the top tank, there is also solder along the bottom and the lower corner tabs. Mine had broken the solder joint at the corners and most of the bottom.

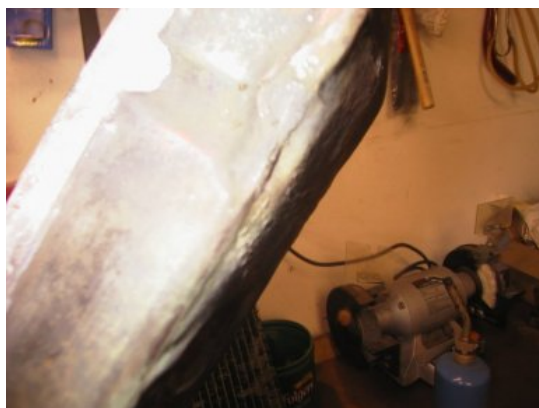
I have one spot that has a folded dent. I don't think I can pound it smooth but will try to reshape the area. I use body tools for this work. I removed several other small dents. The bottom was bulged out due to freezing so I pounded that back and reshaped the sides using a 2" square tubing as an anvil. Came out well.

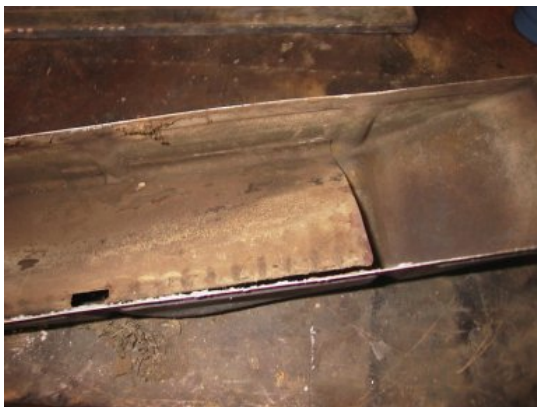
Baffle was loose in most parts:

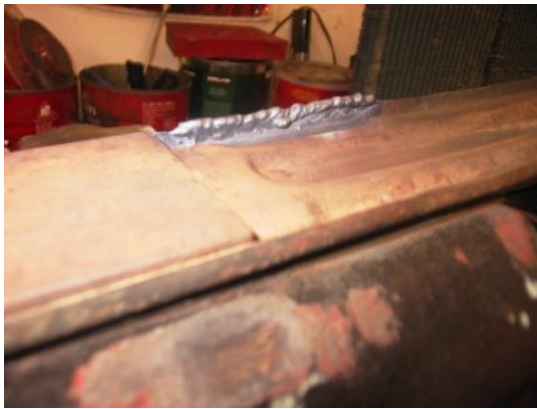
Here is the edge of the frame where acid rot from the battery and rubbing on something ruined the edge. About 1/8" to 1/16" was missing or very thin. The steel is too thin to mig weld so I O/A welded it.

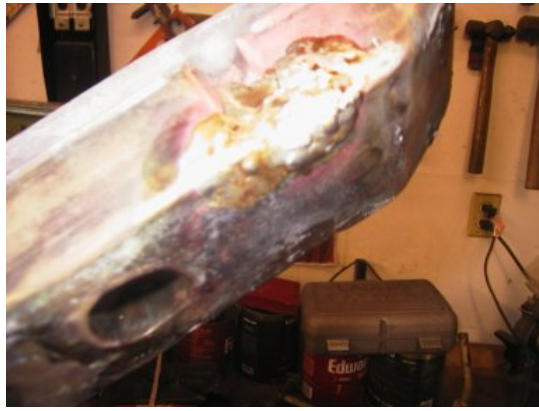
Next I needed to fix a real bad spot. This is where the brass was folded on it's self. I had one small spot where the brass was then layered and there was no way to fix it. So I pounded it all smooth and put a layer of solder over it all:

Since the area was where the "groove" in the side on the tank was, I had to shape things back to look right. I think it came out fine. next step will be to fit the tanks nice and tight and polish the brass bright before I solder it back up. Since the brass is soft, I can touch up the shape real easy. A good tight fit is improtant just like doing plumbing. Once it fits just right I'll tin it with a my tinning flux and then solder it all back up
