G503 WWII Military Jeep Radiator Rebuild Restore WW2 Restoration

This article shows a step by step process of restoring your G503 WWII Jeep Radiator - By Lew Ladwig

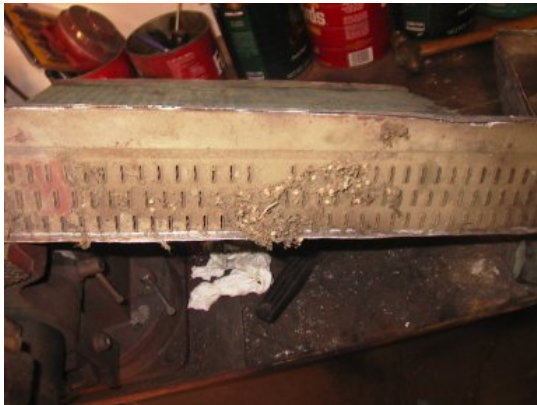
With the top off, look what we found, a wasp nest! Do you think a can of prestone flush would have removed that?

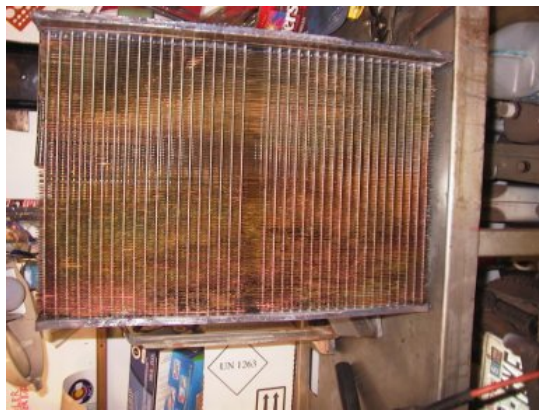
Next, after washing the core, I started to straighten the fins and tubes. I used a small pair of thin flat bladed pliers. You can see in the picture my first pass over the upper half of the fins. Still need to do the lower, ends, and other side: I think I wil give it all a muratic flush when I'm done. Then a bit of a rinse in baking soda water to neutralize the acid, and a good soapy water rinse.

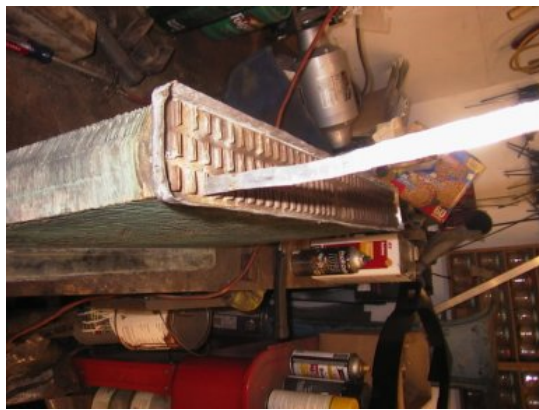
I was able to set up an acid bath. I used muratic acid from Lowes. Since things were warmer it was very effective. I flushed the core several times, gave it a water rinse, and a flush with my lye mix. Lots of dirt, paint, and copper oxides came off. Much of it was now bright copper. I continued to flush and clean inside and out. I used some triox to make sure all was clean: It was nice to see daylight between the fins and thru the tubes! It really cleaned up
