G503 WWII Jeep Replacing Brake Light Switch

A common problem when your G503 WWII Jeep Brake Light no longer works is that the switch on the Master Cylinder has gone bad. It is not expensive or difficult to replace, here are the steps

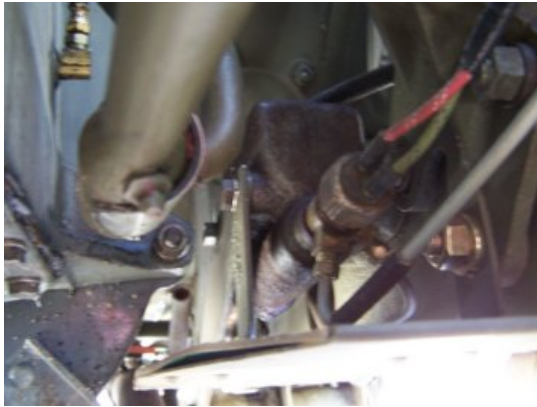
The brake light switch is a common point of failure. The brake light switch is found on the front of the master brake cylinder. There are two ways the brake light switch can fail. 1) pressing the brakes with the light switch on, and nothing lights up. 2) the brake light staying on when the electric light switch is on.

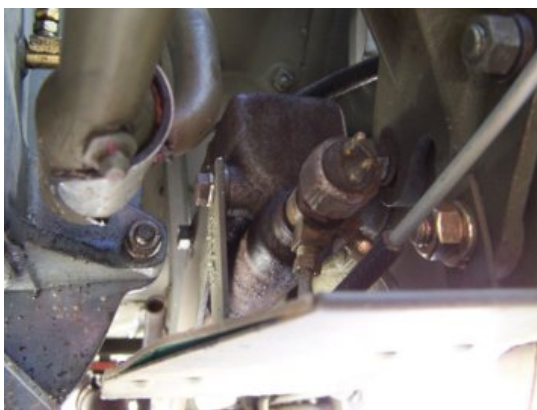
First you want to remove the wires by pulling them off of the terminal on the current switch. If you have a heat shield installed, you are pressed for room and visibility is not that great.
