G503 WWII Jeep Hull Streamline Bakelite Compass Restore

One great tool that is enjoyed on the WWII Jeep is the Hull Streamline auto compass. It adds history and elegance to your historical offroad vehicle. Here are some details on how to restore this cool compass

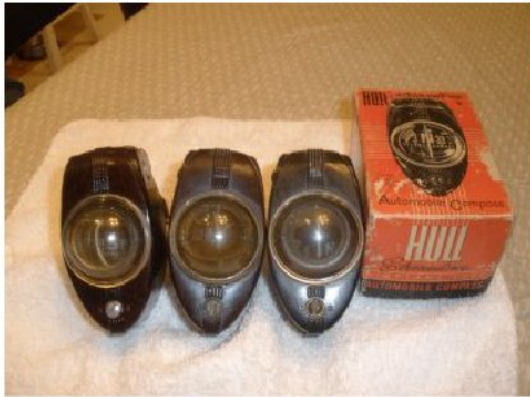
There are a couple different type of WWII Hull Streamline compass that are the correct for the WWII time period. Here you see three brown or black bakelite face plates that are the same

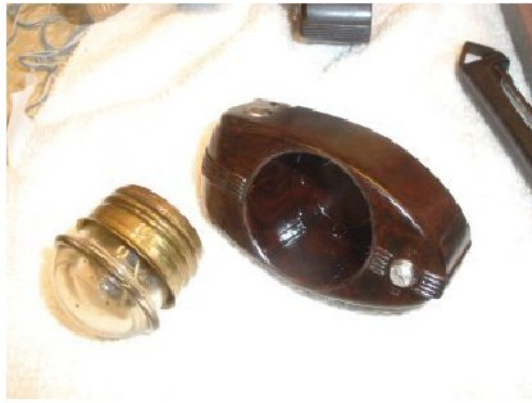
When the glass bulb pops out, you most likely will have some of the fluid all over the device from leakage. Most leak, or are short of fluid.

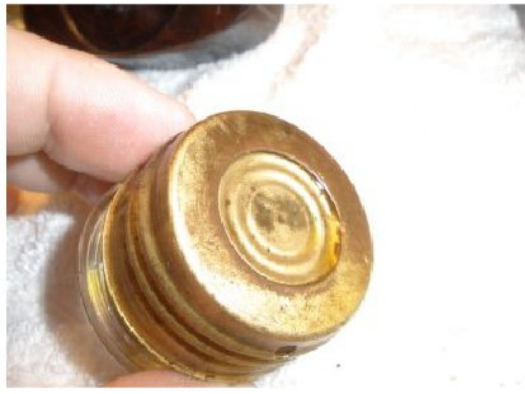
Here is a close up of what you are trying to resolve. There is a brass back plate that is usually frozen to the brass retainer.

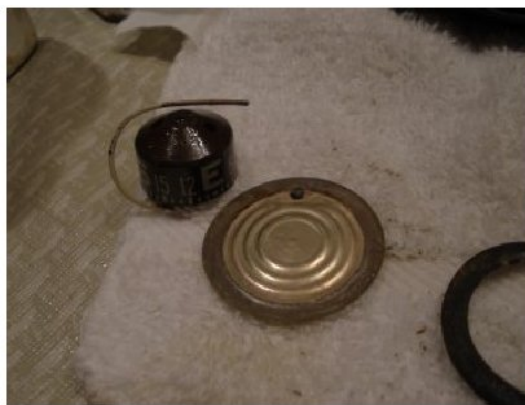
In this case you will see that the small brass "C" shaped wire broke from the back brass plate.

To fix the wire to the back plate I used JB weld. I like this product and it will withstand heat and the keroscene lamp oil I will be filling later, so I applied the JB Weld and let it sit overnight.

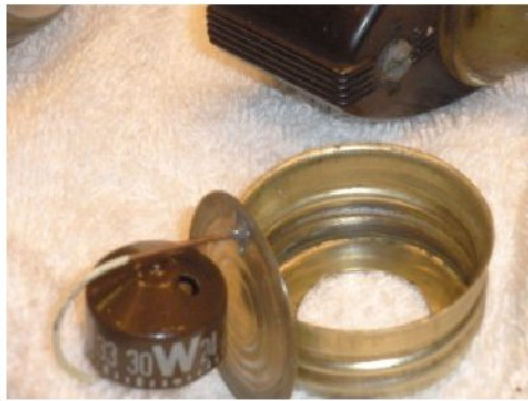
Here is a close up of the patched area. I applied the JB weld with a toothpick.

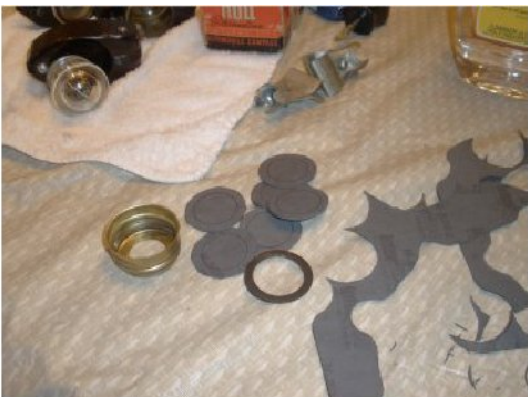
You may need to make a new gasket, as the cork original may not be holding the fluid well enough. I went to Napa who gave me a piece of gasket they were not going to use, so I made some additional gaskets from the piece they gave me.

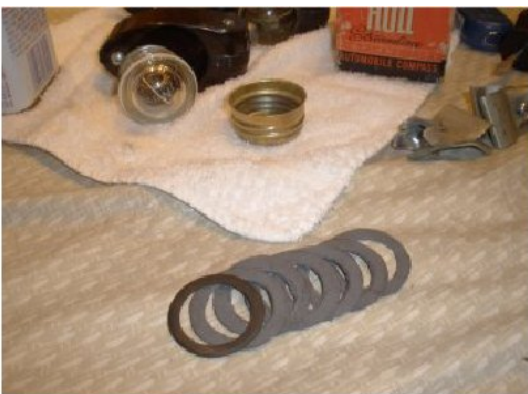
Here you see that they are cut out close to the original

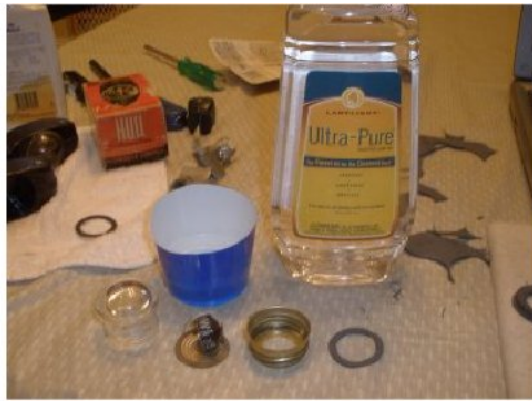
Now that the fix is made to the compass and the gasket is ready, I pour the non odor pure lamp oil into a cup I cut in half. I will submerge the entire glass bulb to remove as much air as possible.

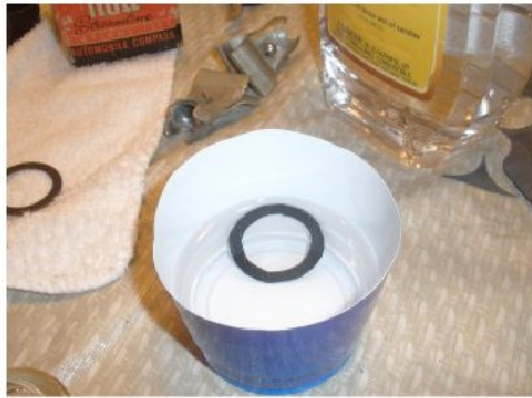
Prior to putting the items together, I soak the new gasket in the lamp oil to get it saturated. This will help when I place the items back together.

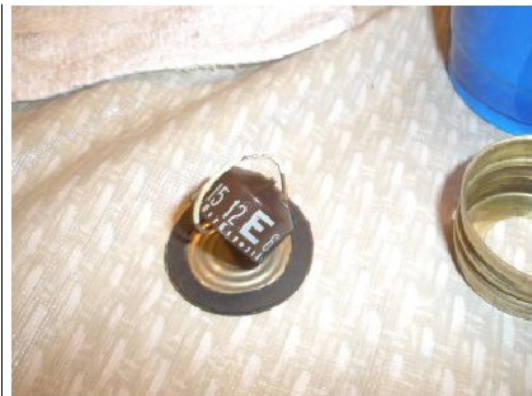
After saturating the gasket, I place it around the back plate to make sure the fit will be good

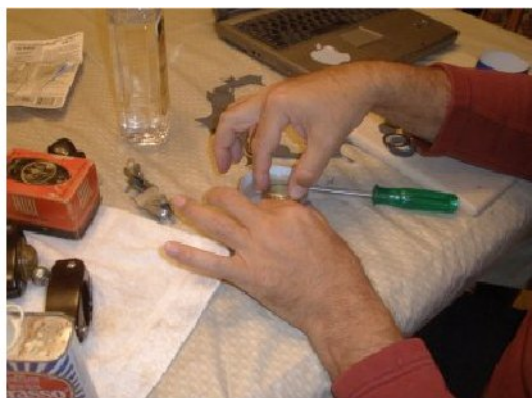
Next, submerge the glass bulb overflowing the glass bulb, then place the back plate in the glass bulb and screw on the retainer with the bulb completely submerged

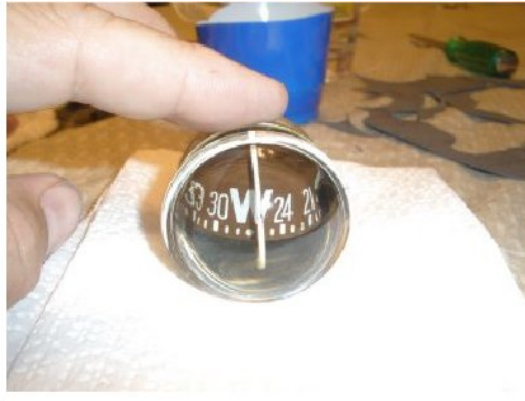
Screw the retainer on tight, and pull out of the container of lamp oil. Wipe off and you should see very little to no air in the glass bulb

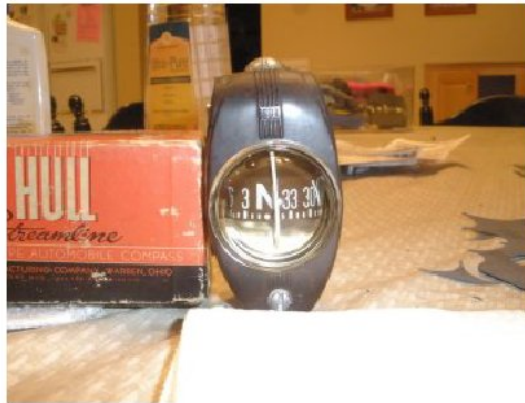
You may want to let the glass bulb sit on a paper towel for a while to see if it is leaking. If so, tighten or repeat the steps. When your done, line up the white wire vertically in the bakelite container and your done
